RAPID ENVIRONMENTAL ASSESSMENT

Capsized ferry 'MV Princess of the Stars' Republic of the Philippines

**A joint European Commission/United Nations
Environmental Emergency Response Mission**

July 2008

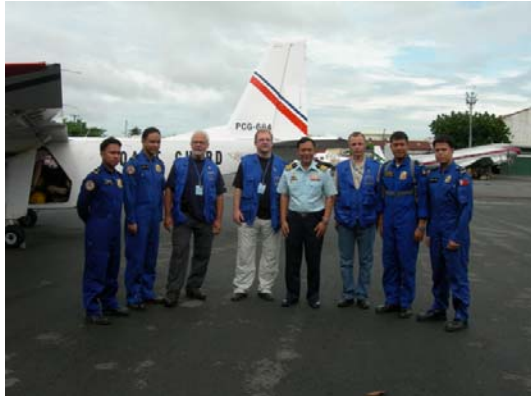
Picture 2

On 15 July, the national coast guard organised an aerial surveillance (picture 2) and a survey of the wreck (pictures 3, 4 and 5). As an oil slick had been reported, the coast guard's Oil Spill Department deployed a boom around the wreck which is clearly visible from the pictures.

During the aerial survey, no surface oil contamination was observed. However, due to the chemical nature of the fuel (marine diesel oil) and the likelihood that any spill could have evaporated, the experts could not confirm whether or not there had been a leakage of oil.

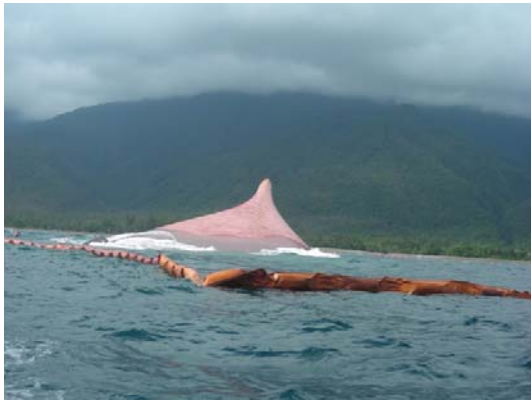
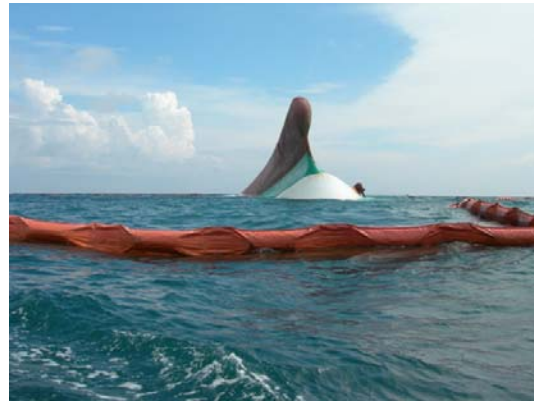
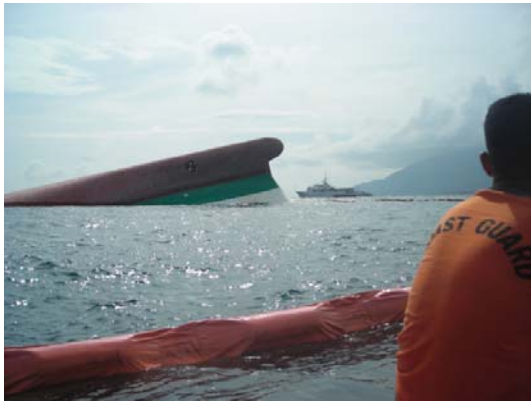
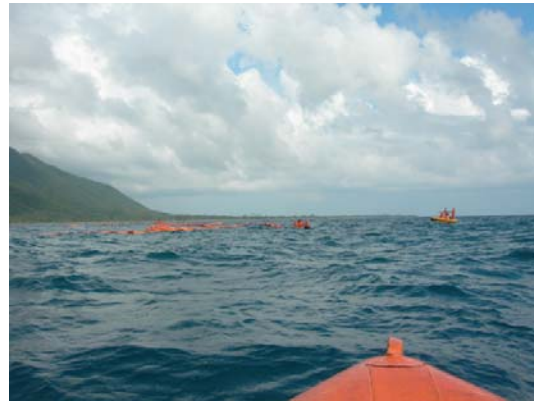
To further identify possible sightings of oil or sheen on the water, the expert team performed a survey by boat around the wreck in the afternoon (pictures 6, 7, 8 and 9), during which no oil was sighted.

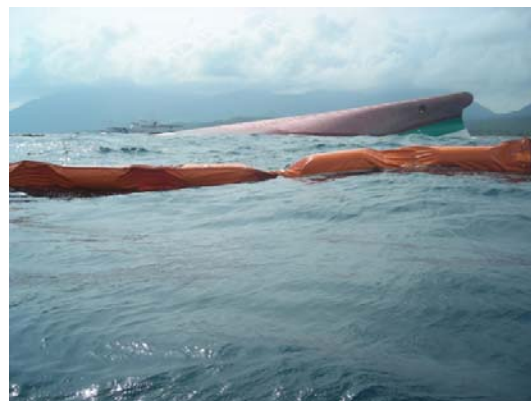
Picture 10

It appeared difficult to maintain the boom in place due to meteorological and oceanic conditions (wind and waves). The coast guard decided to anchor the boom, but did not succeed due to sea depth and weather conditions. In addition, the boom twisted around itself (pictures 10 and 11), and seemed unsuitable for these sea conditions (pictures 12 and 13 and Appendix 1).

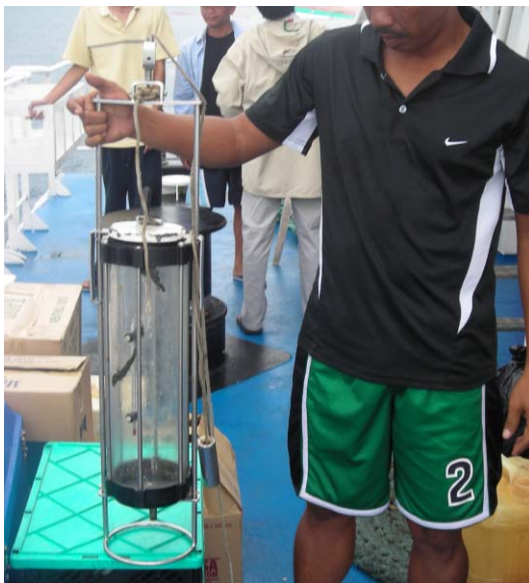
Picture 14

A mobile laboratory has been operational since 15 July. The Environmental Management Bureau of the Department of Environment and Natural Resources (EMB-DEHR) took seawater samples once a day with a Niskin bottle (picture 14). Samples are taken at four points, 20 metres from the wreck at constant depth (≈ 33 m), and at one point in the direction of the open sea as a control point. In addition, *in situ* measurements of the following oceanic parameters; water temperature (≈ 29 °C), dissolved oxygen (≈ 6.09 mg.L⁻¹), pH (≈ 8.23), salinity (30.2 to 30.4 mg.L⁻¹), conductivity and total dissolved matter (picture 15), are taken.

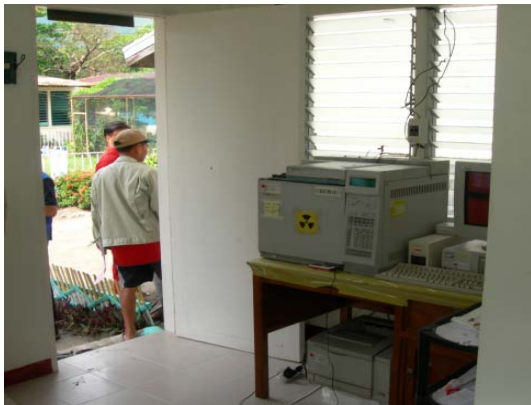
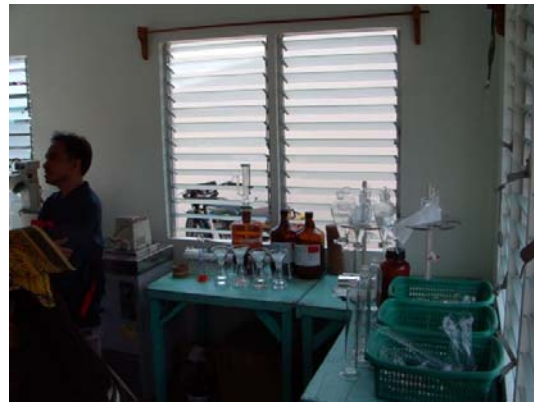
Pictures 16 and 17 show the mobile laboratory in operation. The mobile laboratory can perform sediment and sea water analyses. For biological analysis, samples are sent to Manila.

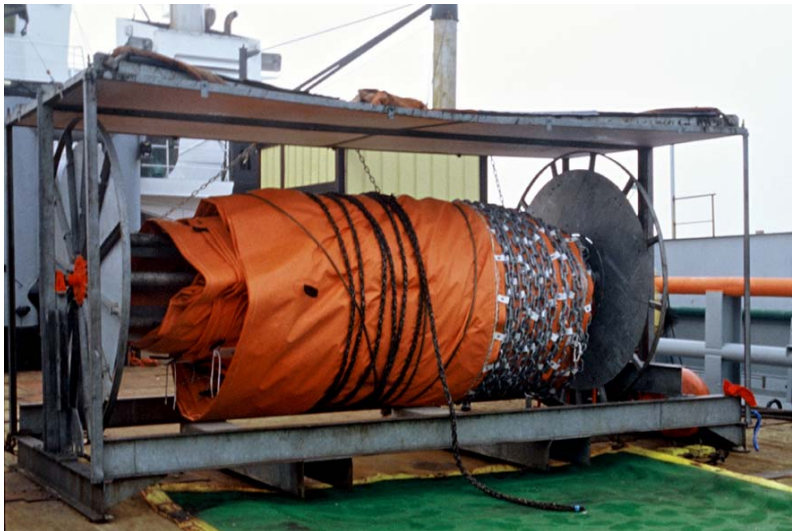
Type of boom which could be deployed in open sea

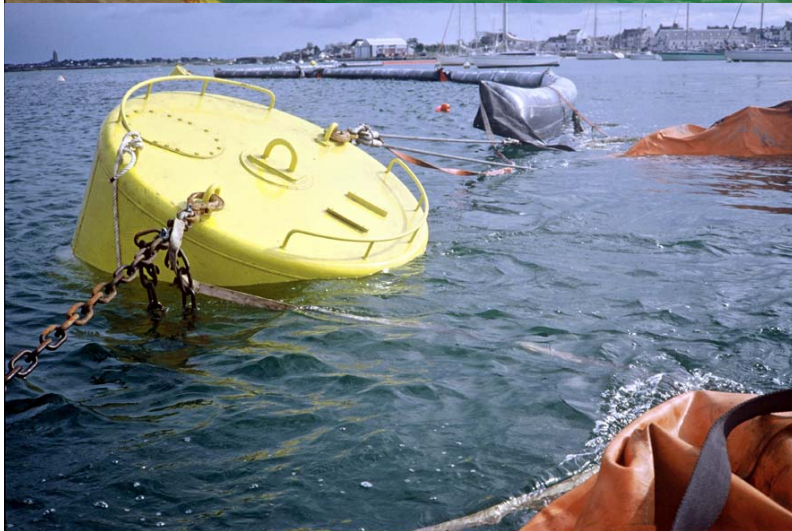
Example of at sea anchorage

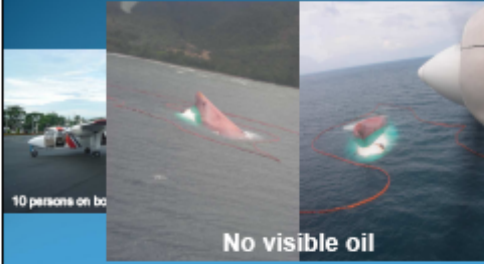
ON SCENE – Aerial Survey

10 persons on board

No visible oil
